**MPDES Storm Water Small MS4 Annual Report Form**

Small MS4 Authorization Number: MTR040002

Small MS4 Name: City of Bozeman

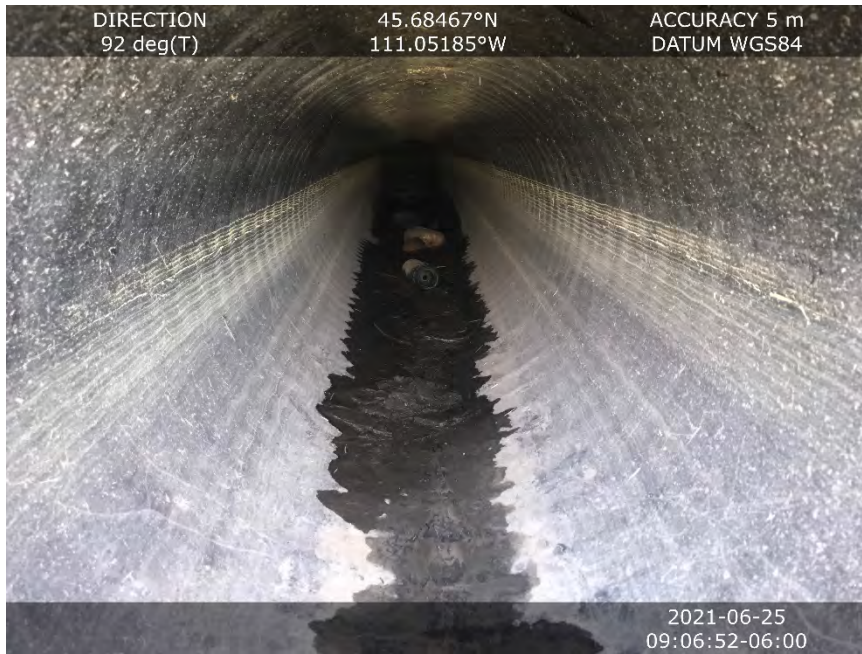
Image 5  
Evidence of high flows since last year. Slight debris in outlet structure.

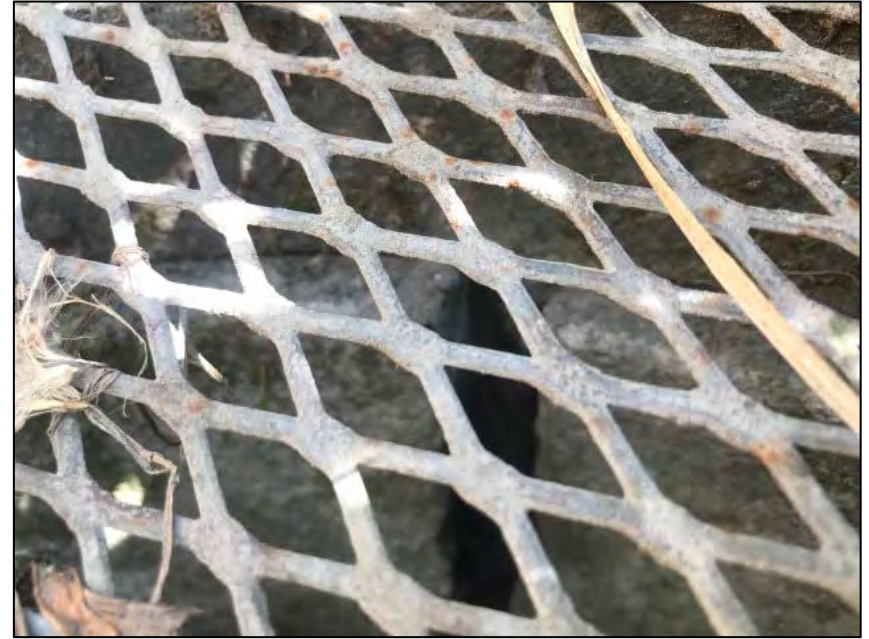
Image 4  
Outlet structure; notched weir closeup.

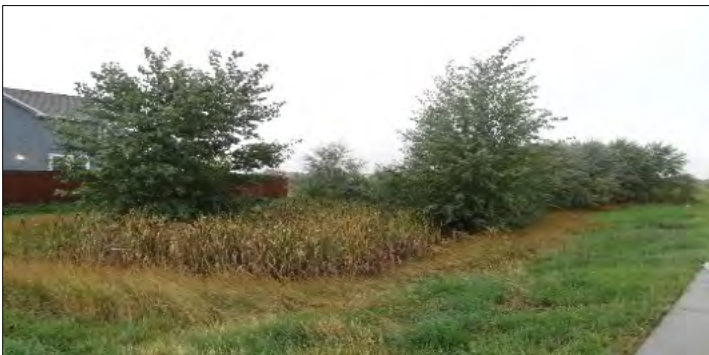
Image 2 - Overgrown vegetation

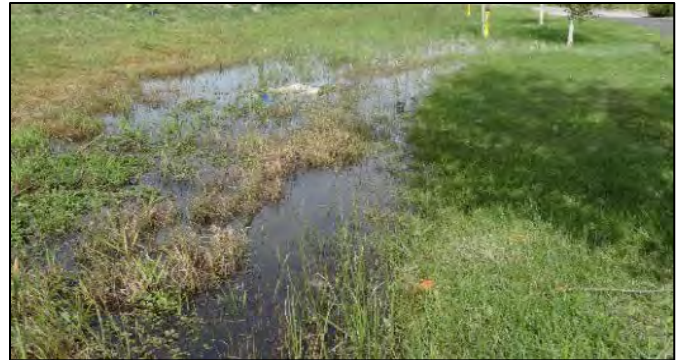
Image 5 - Water 3-days after rain event

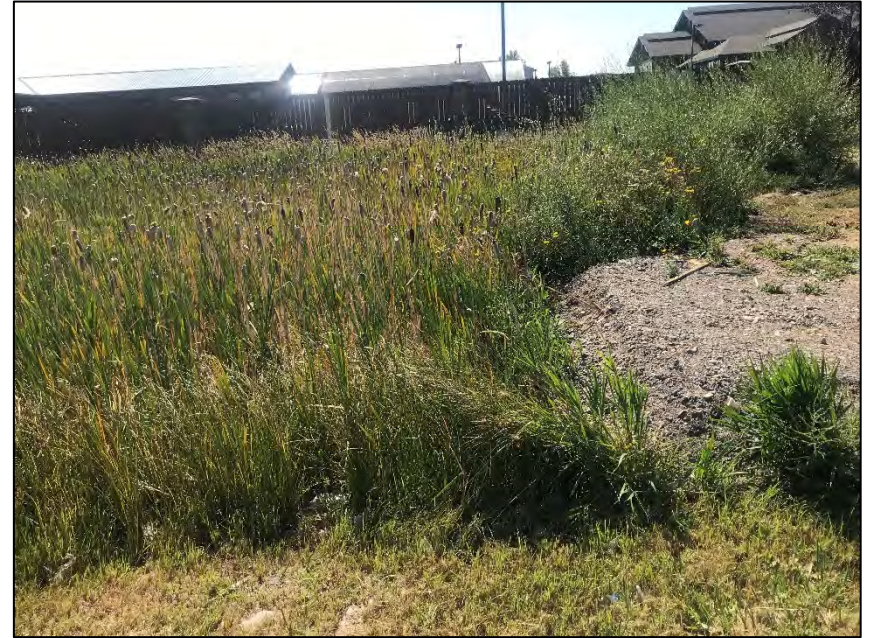
Image 4  
Northwest corner of detention basin. Note fill on right, likely from snow removal and storage efforts (south view).

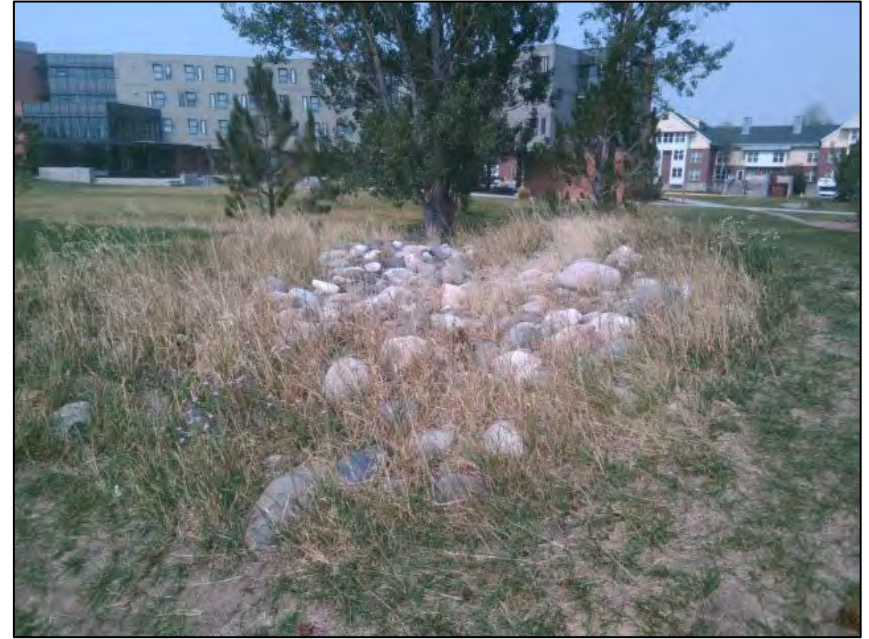
Image 4  
Cobble reinforced emergency spillway.

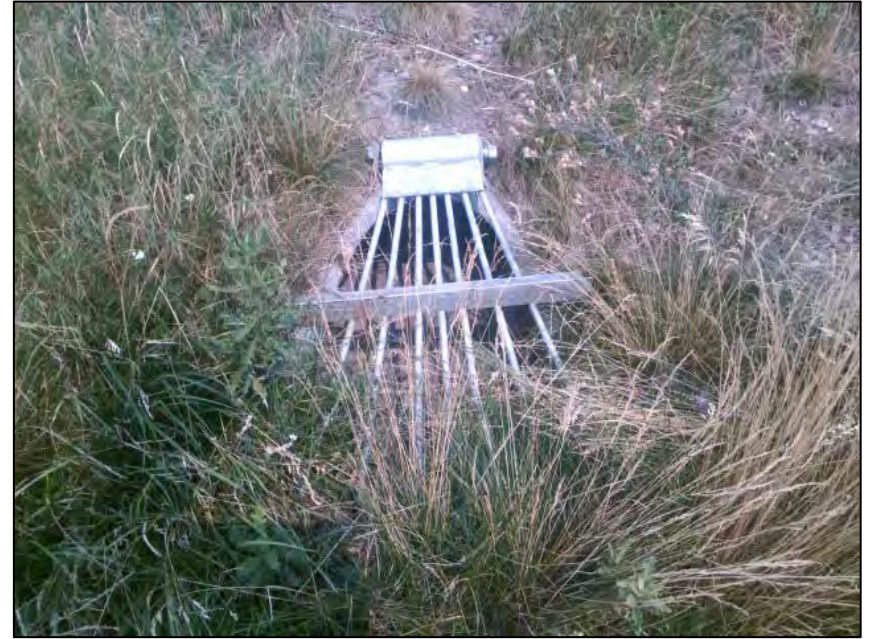
Image 4  
Inlet structure (northeast view). Overgrown vegetation.

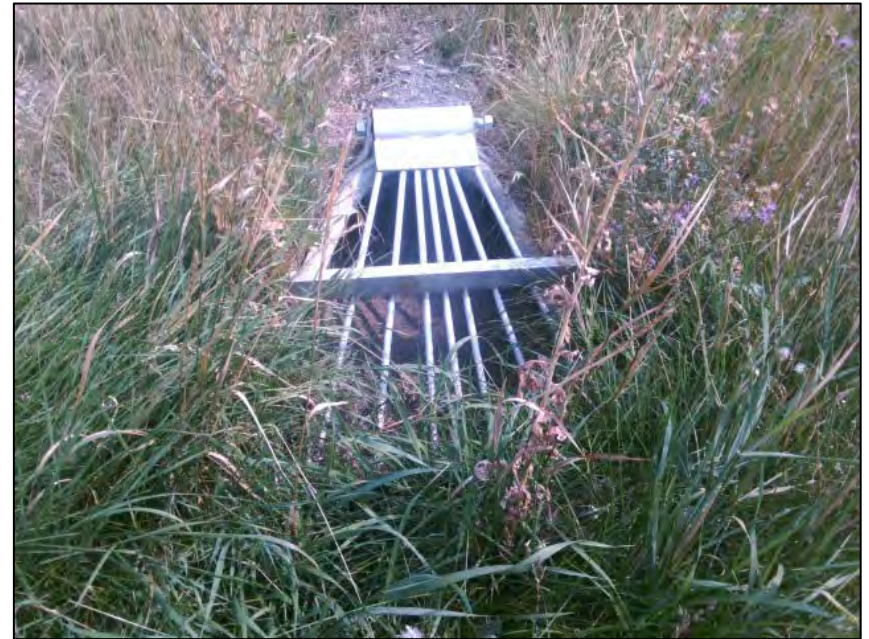
Image 6  
Inlet structure facing (northeast view). Overgrown vegetation.

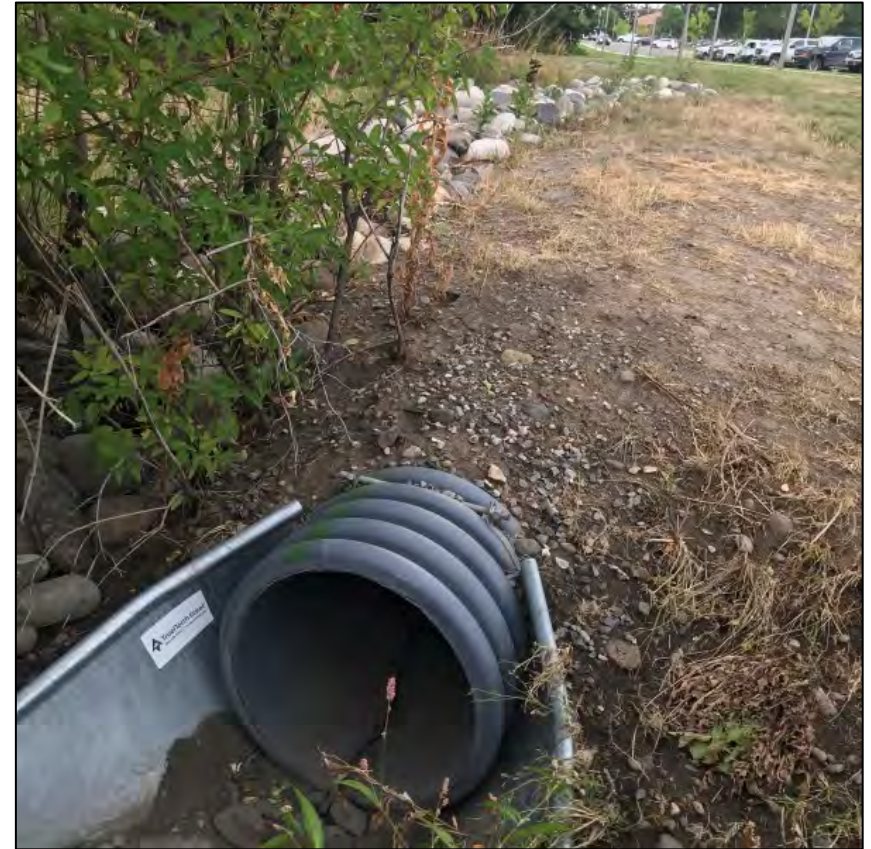
Image 4  
Outfall, 18" HDPE (east view).

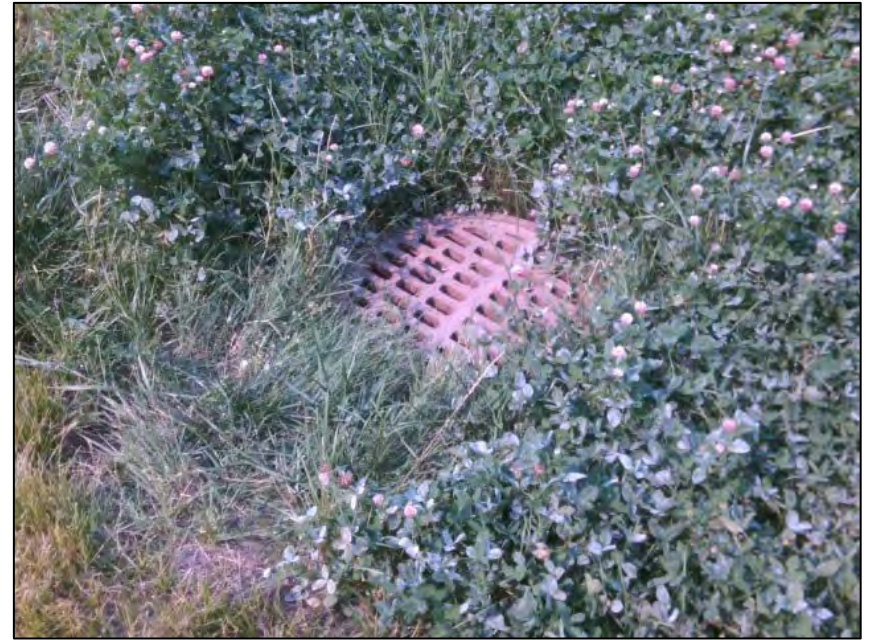
Image 6  
Drywell; vertical infiltration drain. Note heavy cover of red clover.

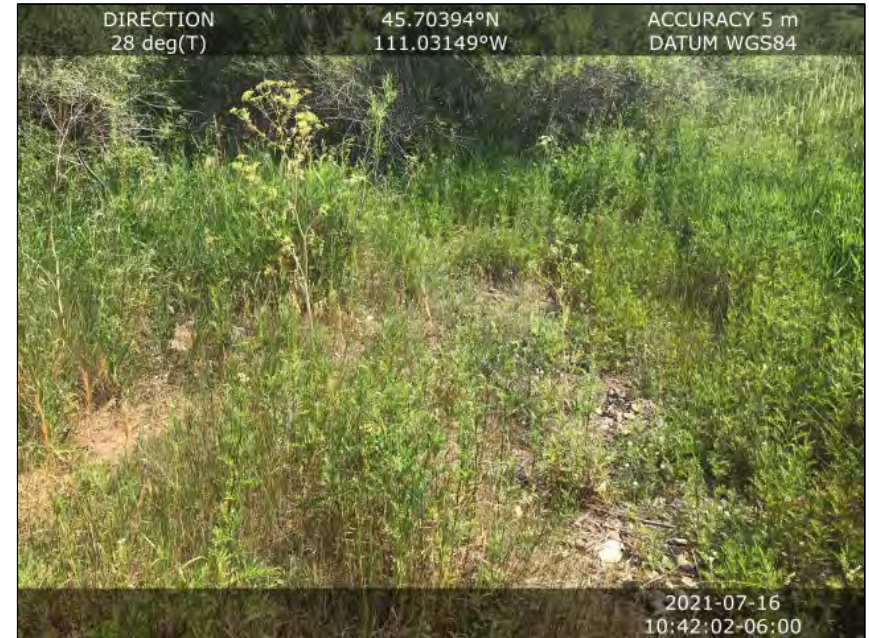
Image 2  
Looking east at edge of the detention impoundment.

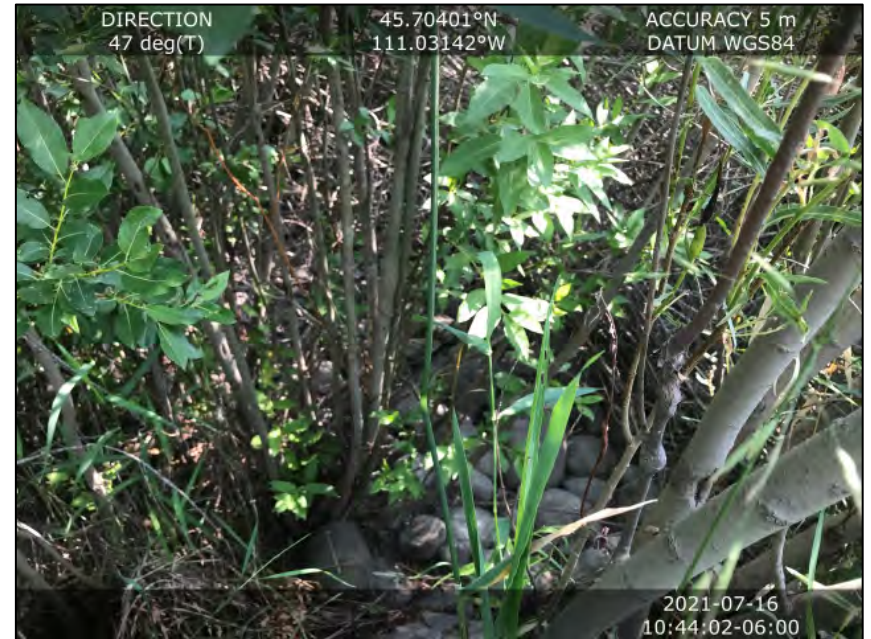
Image 4  
Outlet channel looking northeast. Note overgrown vegetation.

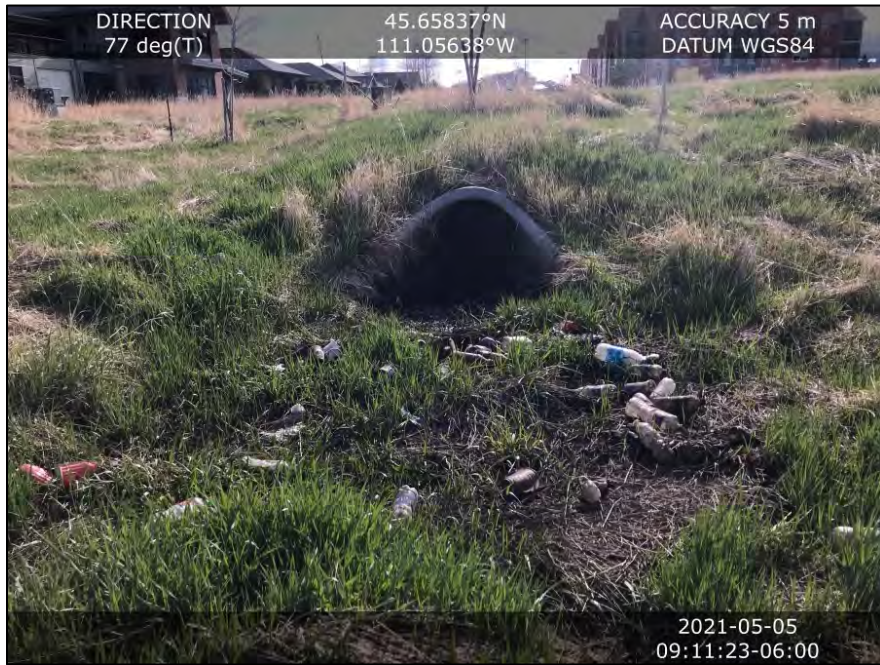
Image 6  
Trash and small amount of sediment at facility inlet. (east view)

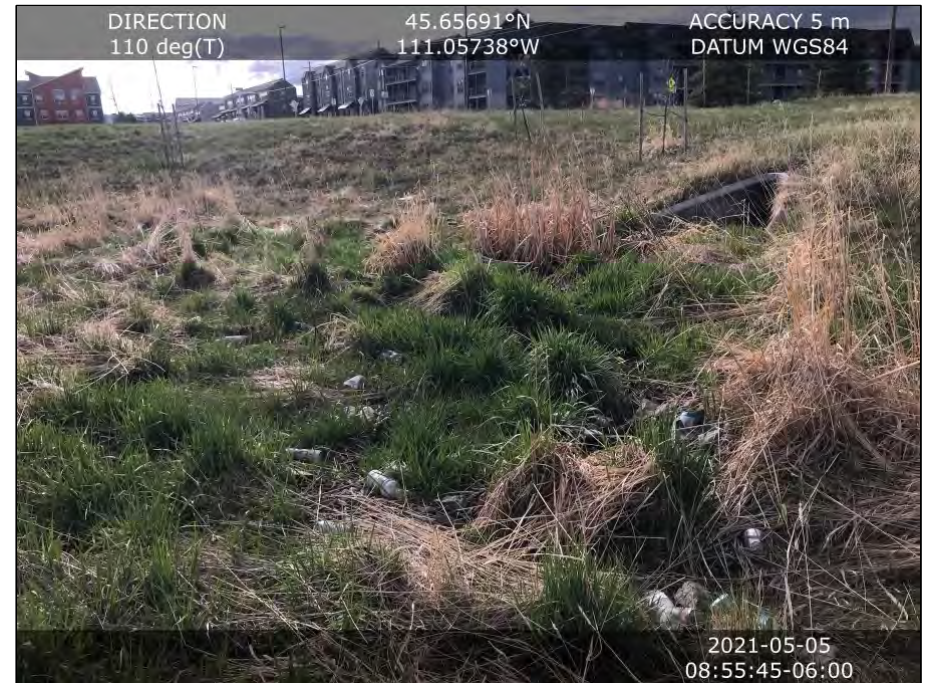
Image 2  
Facility inlet with sediment and trash beginning to accumulate. Overall, taking a very small amount of volume. (east view)

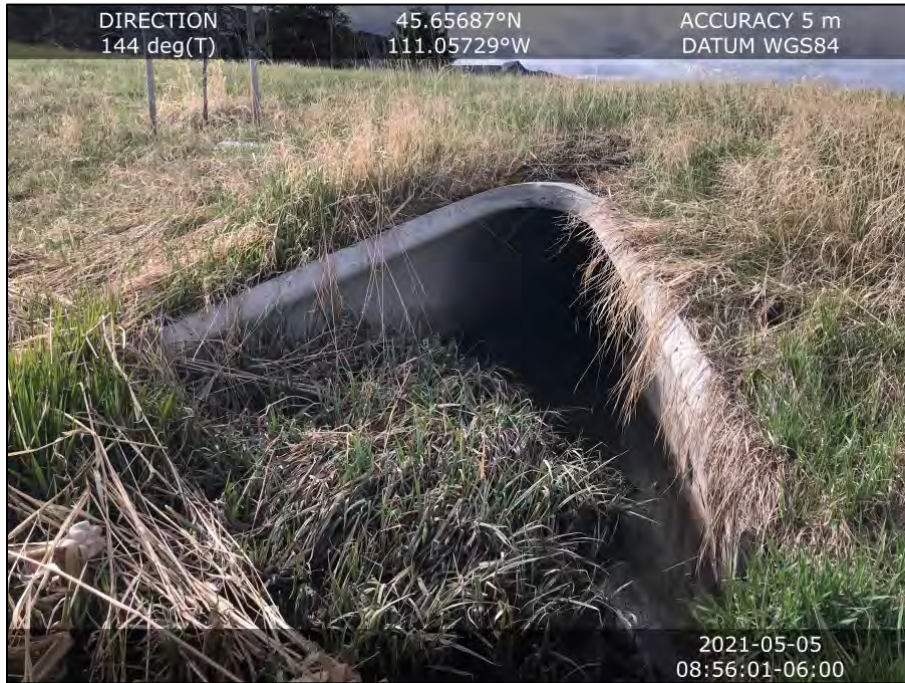
Image 3  
Sediment and standing water at facility inlet. (east view)

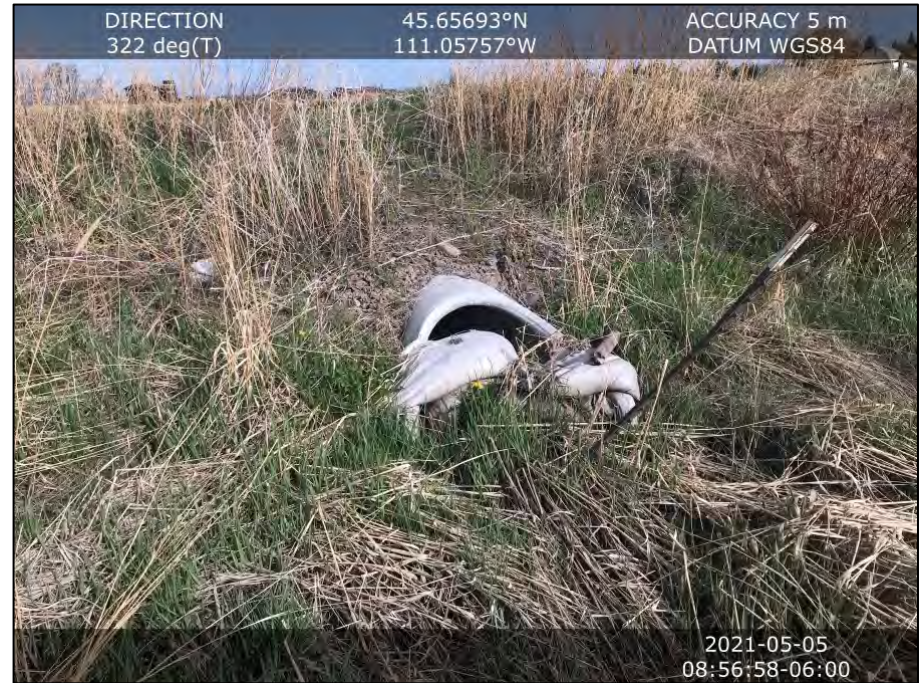
Image 4  
Facility outlet to outlet structure. Sand bags are intact but not meant to be permanent. There is one phase of construction still to be completed which leads to this facility. (west view)

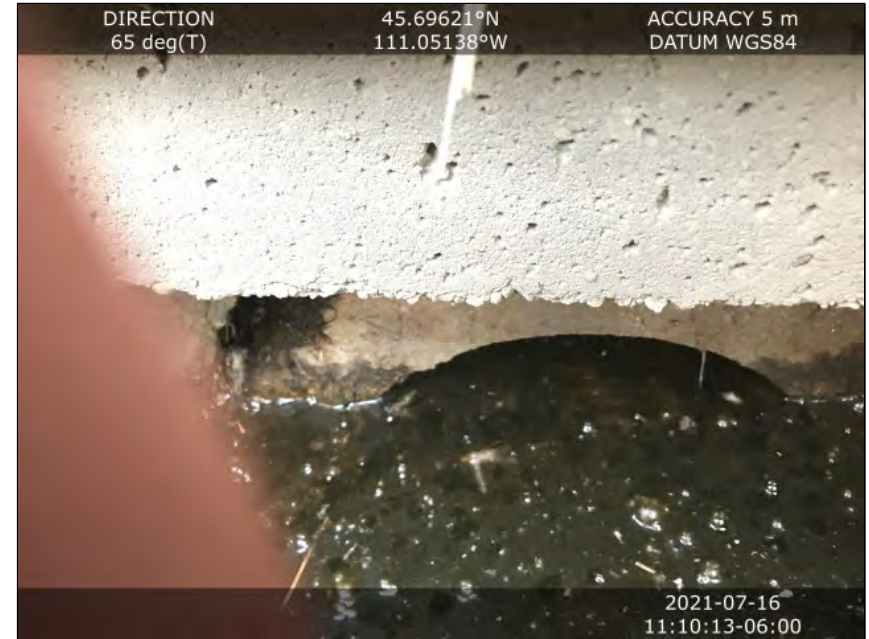
Image 2  
Water backed up into inlet structure (close-up view).

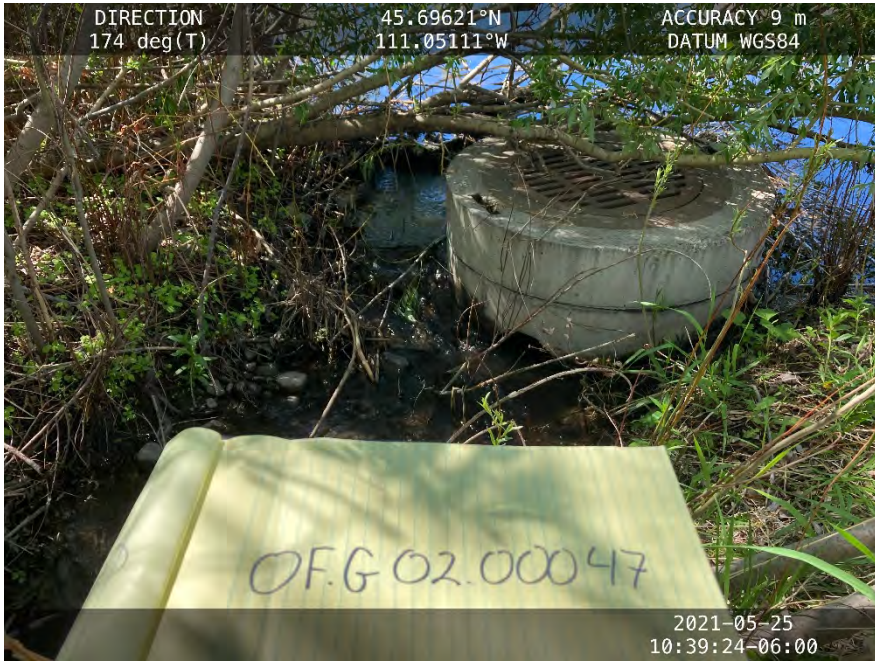
Image 3  
Water flowing through facility / around outlet structure

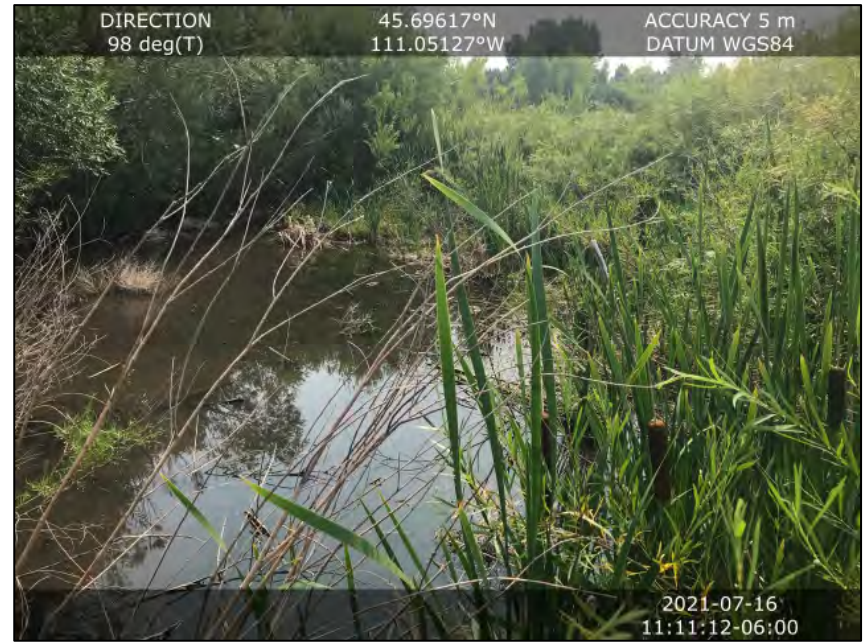
Image 4  
Standing water in facility (south view).

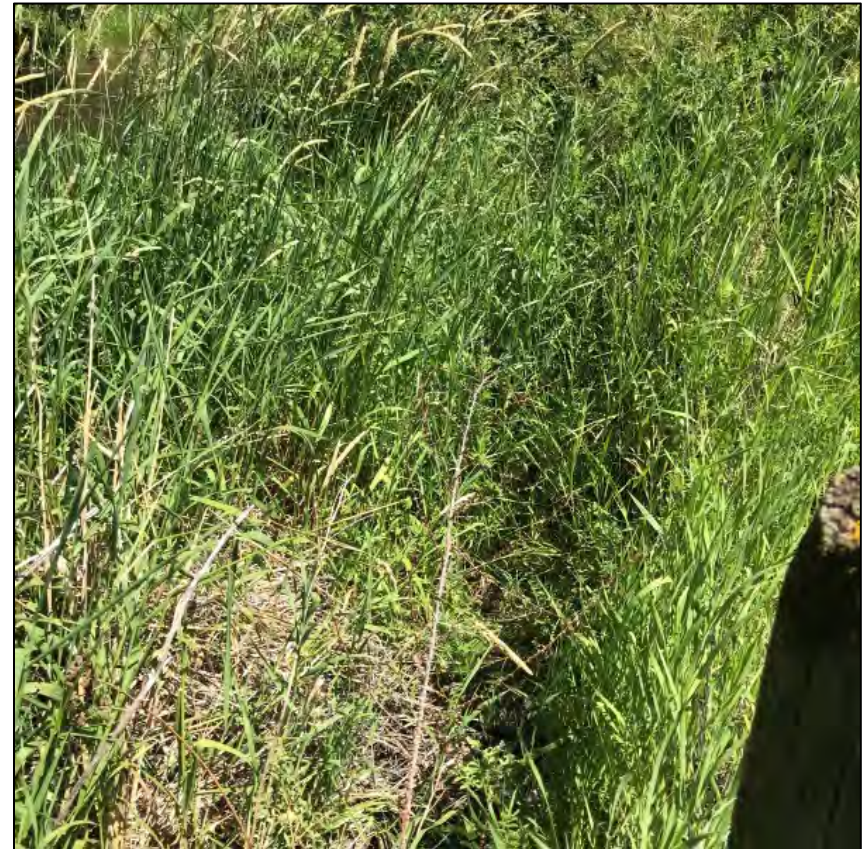
Image 6  
Outfall. Grass is tall but the outfall has a clear path to the East Gallatin River (southeast view).
