**MPDES Storm Water Small MS4 Annual Report Form**

Small MS4 Authorization Number: MTR040002

Small MS4 Name: City of Bozeman

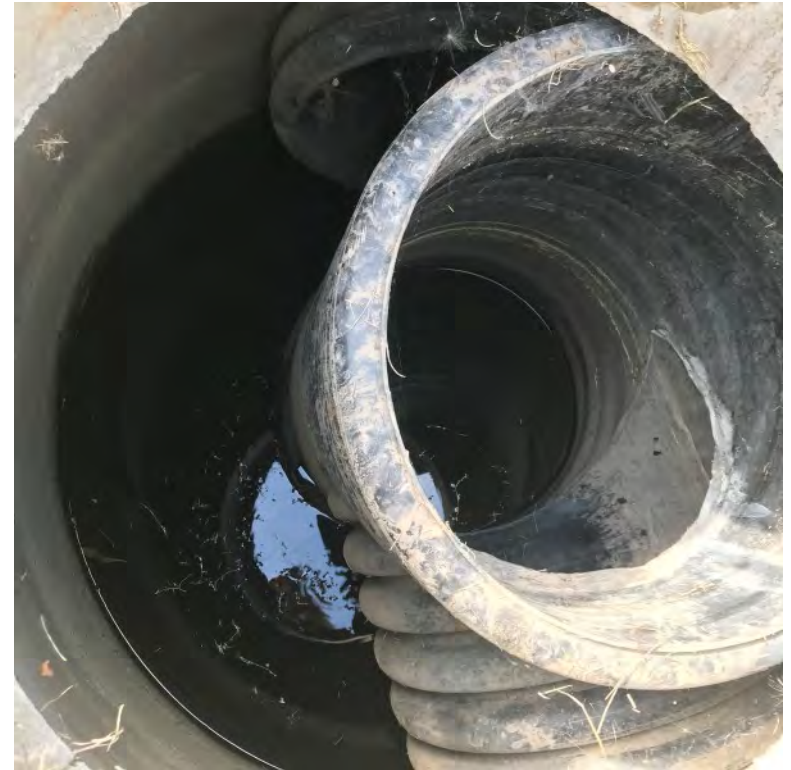
Image 2  
Outlet structure. Flow is from top of photo, to tee, bottom of photo to outfall. (close-up)

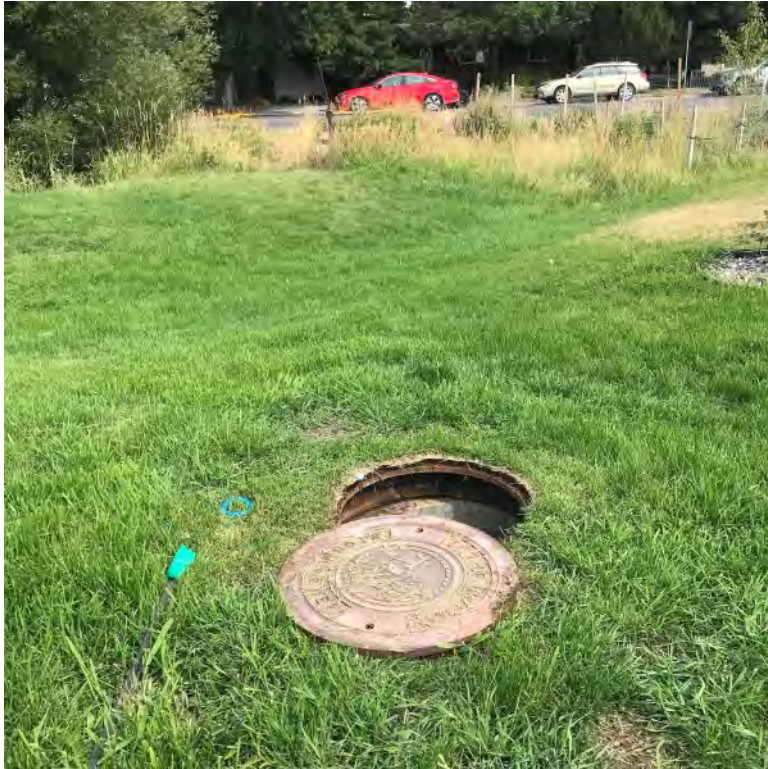
Image 3  
Outfall is below long grass at upper left of photo. (east view)

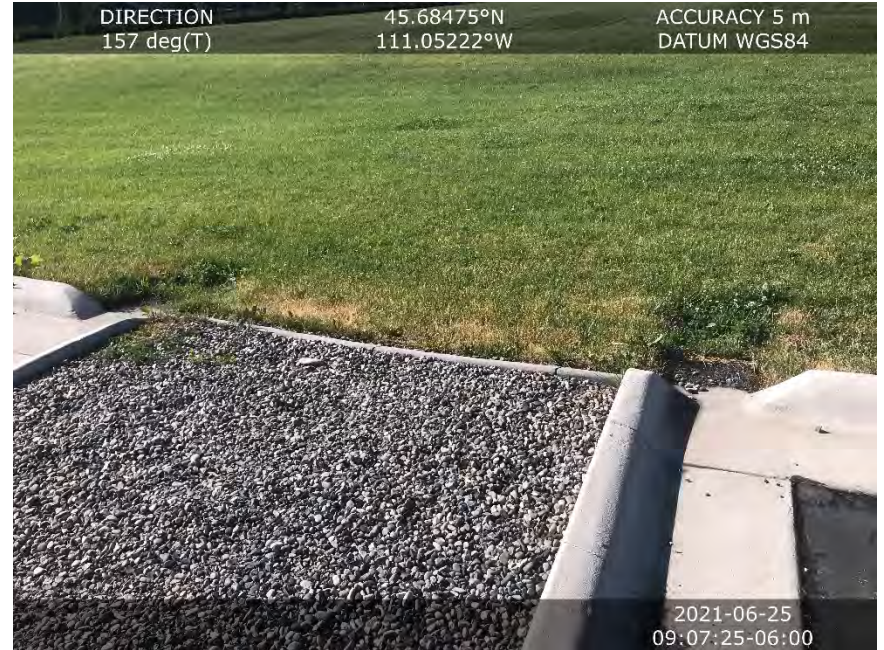
Image 4  
Curb cuts leading to facility. This facility also accepts flow from the south and west fields. (south view)

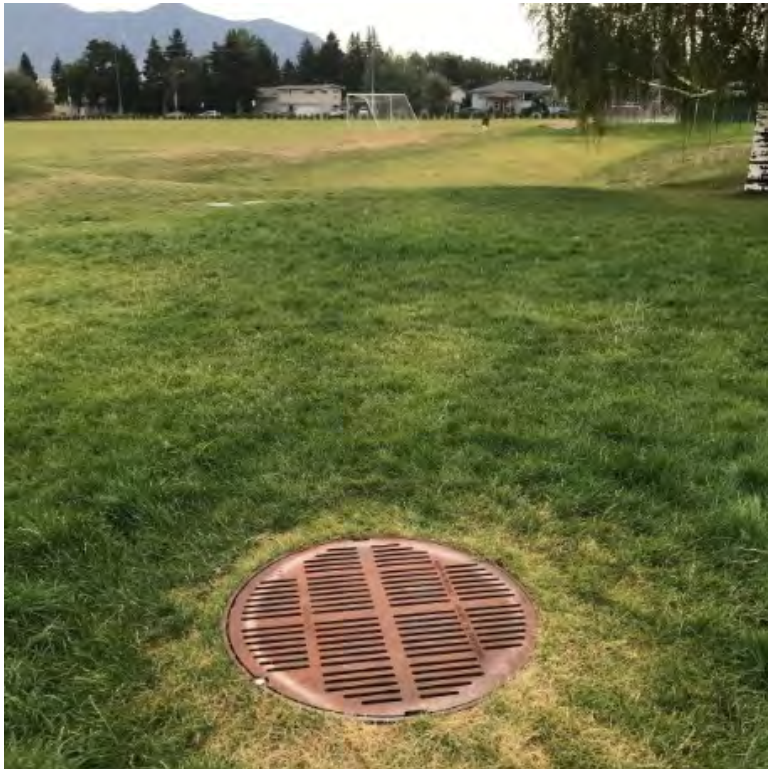
Image 3  
Slotted manhole, leads to basin at center of photo. Parking lot drains from curb cut by the birch tree at upper right. (northeast view)

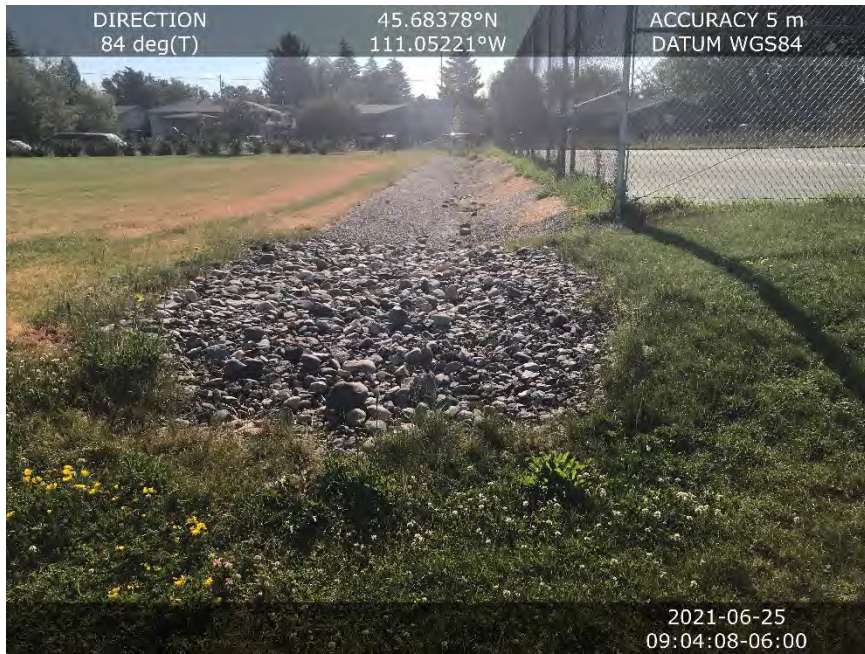
Image 5  
Overflow channel of gravel and asphalt leading to Mandeville Creek. (east view)

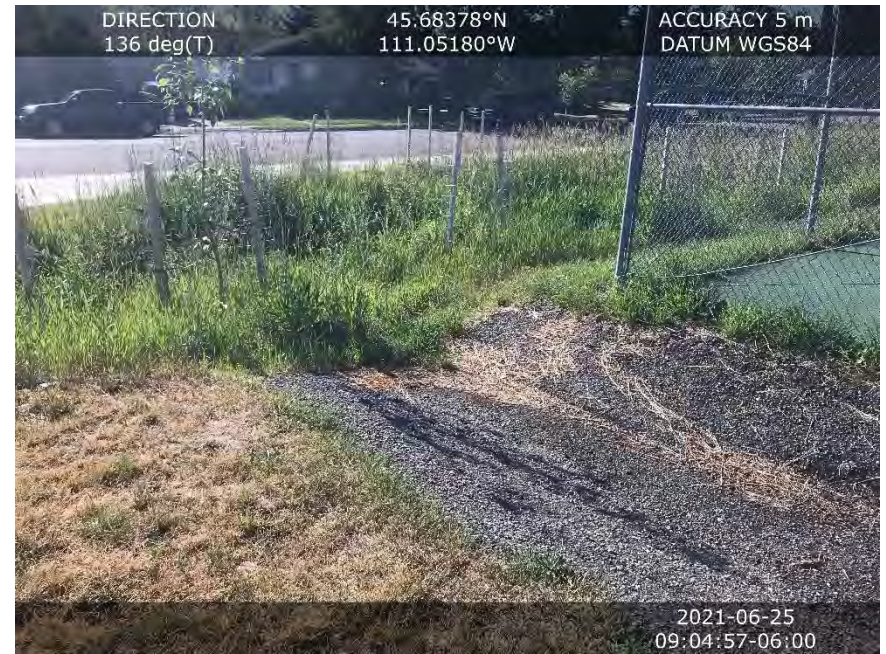
Image 6  
Overflow channel and outfall. (southeast view)

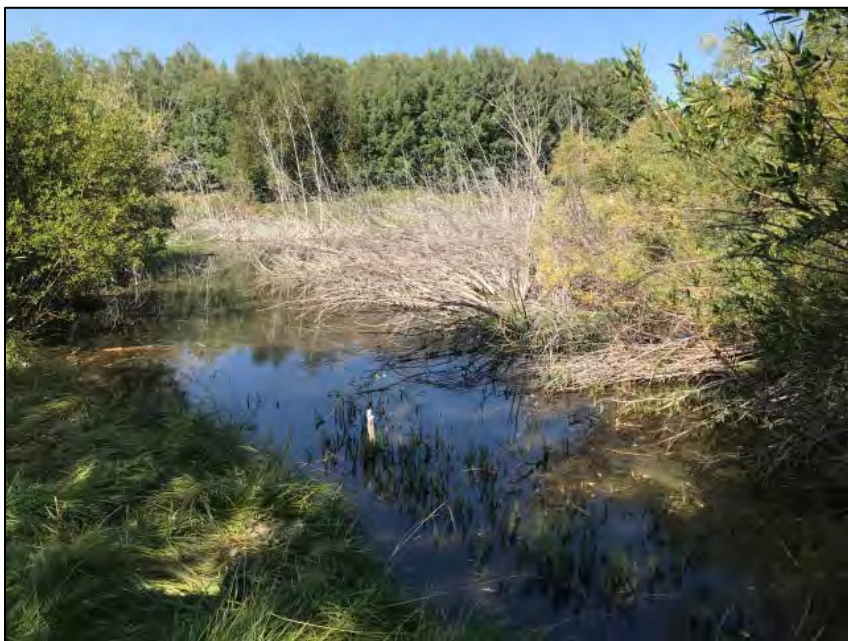
Image 1  
Detention pond (west view); standing water, dead and decadent tree and shrub vegetation layer.

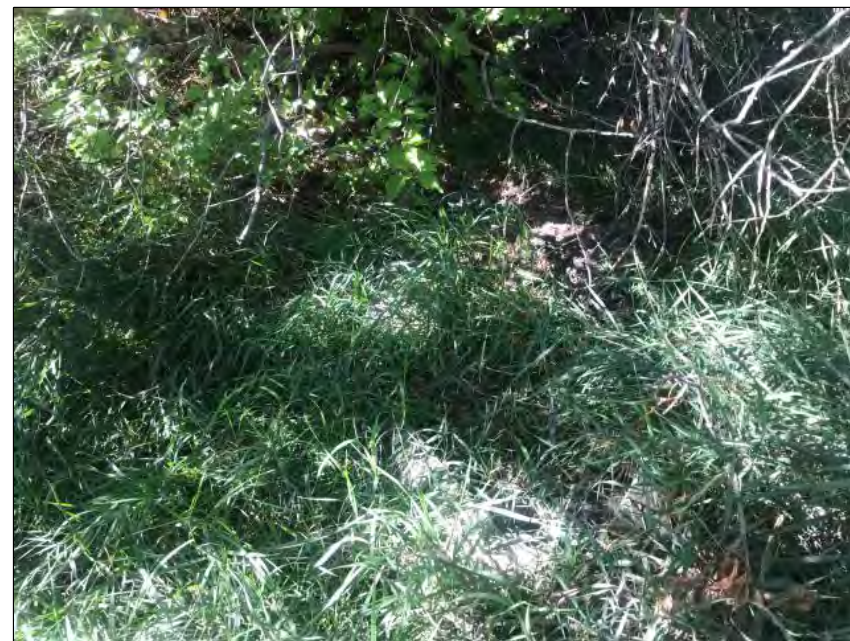
Image 2  
Inlet from road CMP; abundance of vegetation clogging structure.

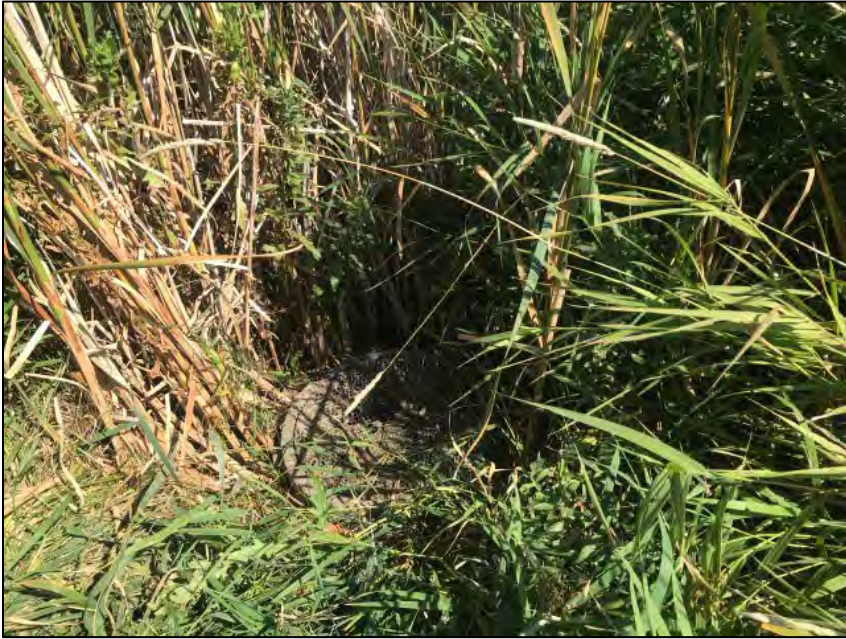
Image 3  
Outlet structure; clogged with vegetation.

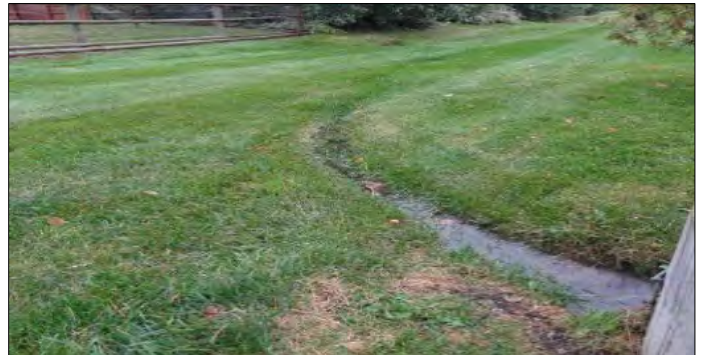
Image 3 - Erosion causing channelized flow

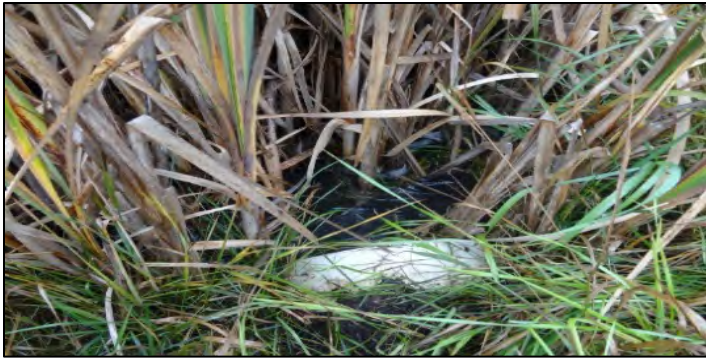
Image 4 - Obstructed inlet pipe

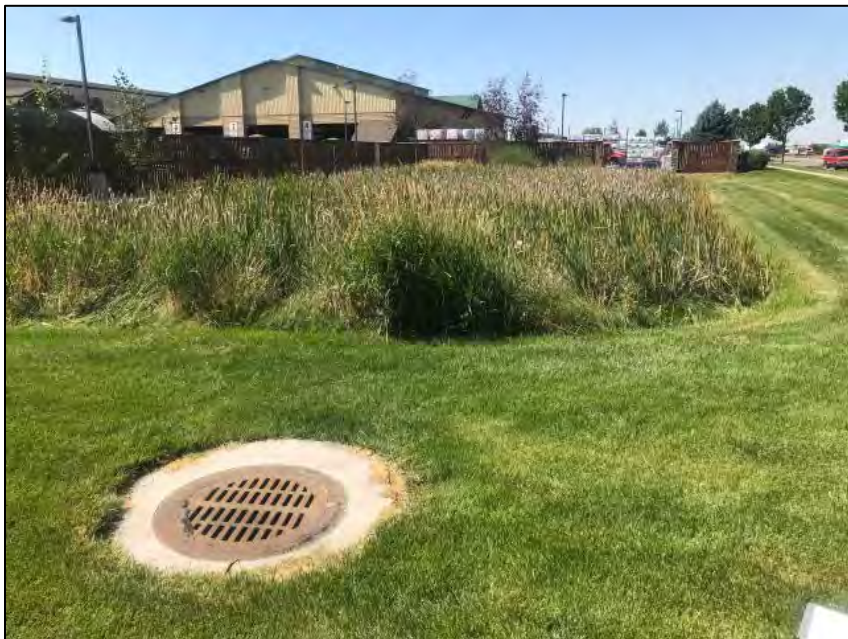
Image 1  
Facility overview (west view).

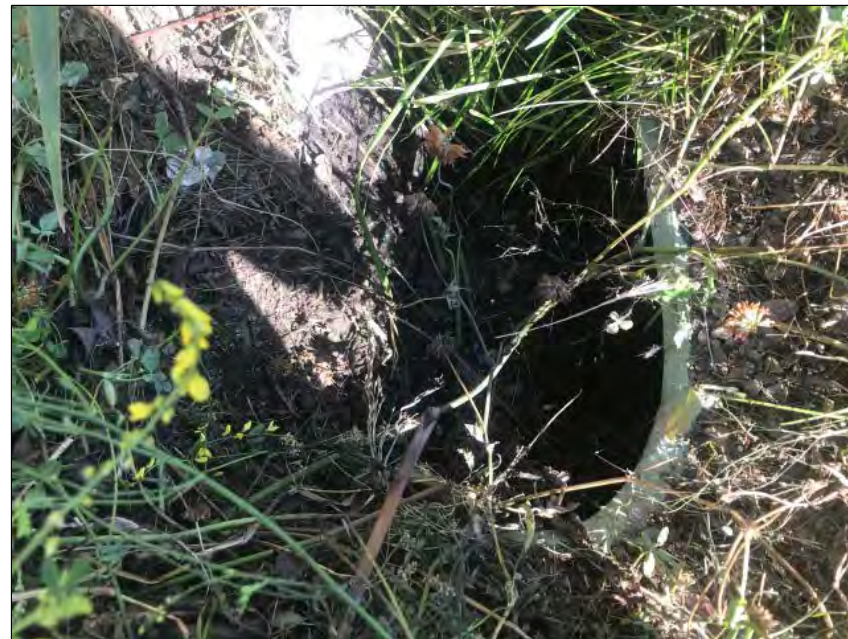
Image 2  
Inlet pipe with accumulated sediment.

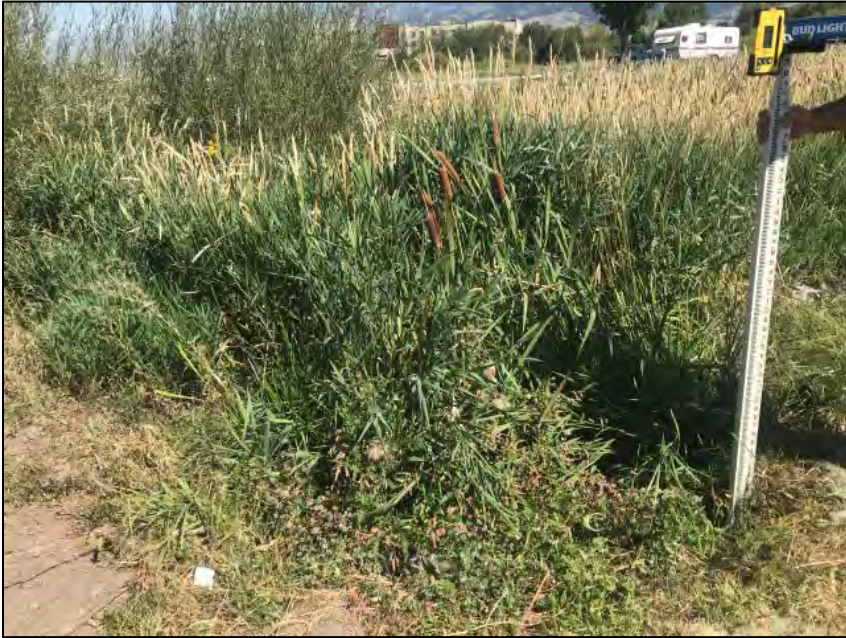
Section 5: Quantitative Analysis				
Vegetation	Cover type	% Within facility	Notes	
	Bare ground	5	Recently placed or disturbed soil in the northwest corner.	
	Aquatics	75	Heavy overgrowth of cattails choking inlet and outlet structures.	
	Grasses/Herbaceous	20		
	Trees >3" DBH	0		
	Shrubs	0		
	Total	100		
Elevation Analysis	Location	Reading (ft)	Elevation (ft)	Notes
	SRV#CP Control Point	4.56	4727.00	
	SRV#1 Inlet	6.75	4724.81	
	SRV#2 Outlet	7.64	4723.92	
	SRV#3 West of Center	7.36	4724.20	
	SRV#4 Center	7.42	4724.14	
	SRV#5 East of Center	7.42	4724.14	
	Summary	Bottom is uniform, but northwest corner appears to be filled in; aerial images confirm.

Image 3  
Inlet pipe location (at survey stadia); note heavy overgrowth of detention basin.

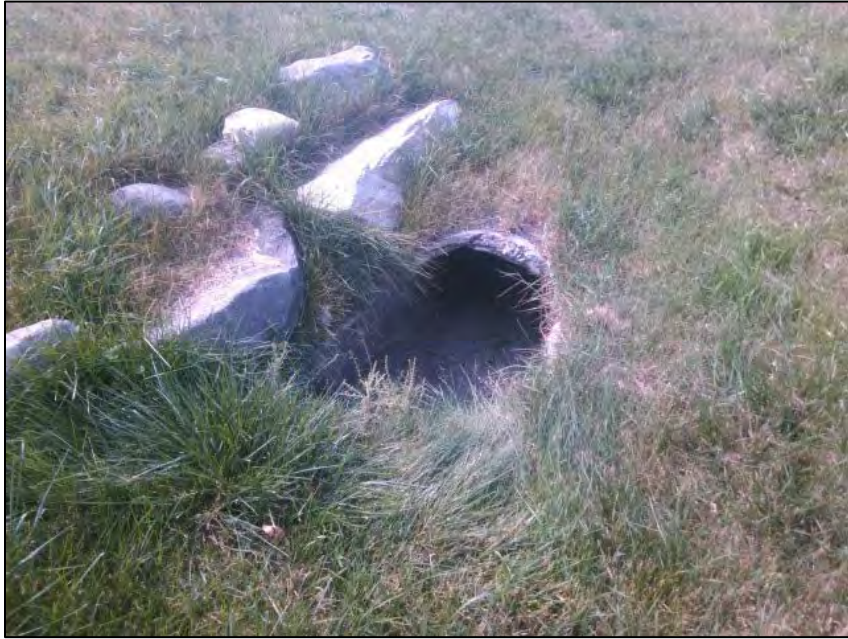
Image 3  
Facility inlet/outlet. Small amounts of sediment in pipe.

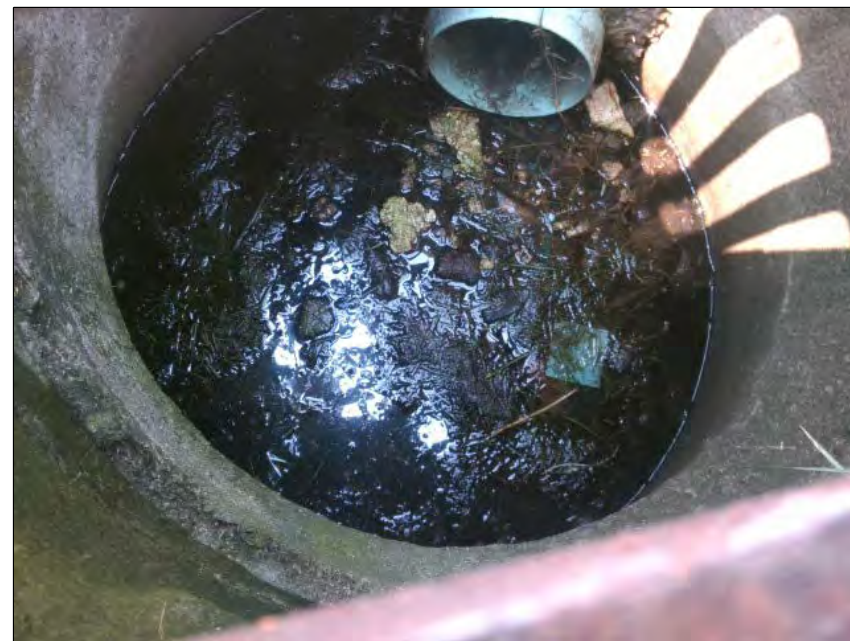
Image 2  
Outlet structure sump with debris. (Close-up)

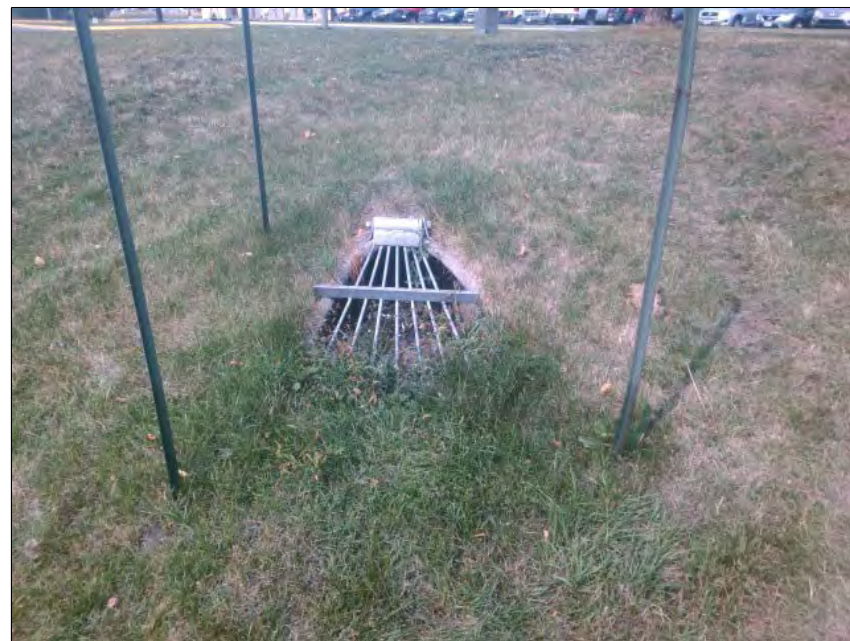
Image 2  
Pond inlet (west view). Small amounts of debris and sediment behind trash rack.

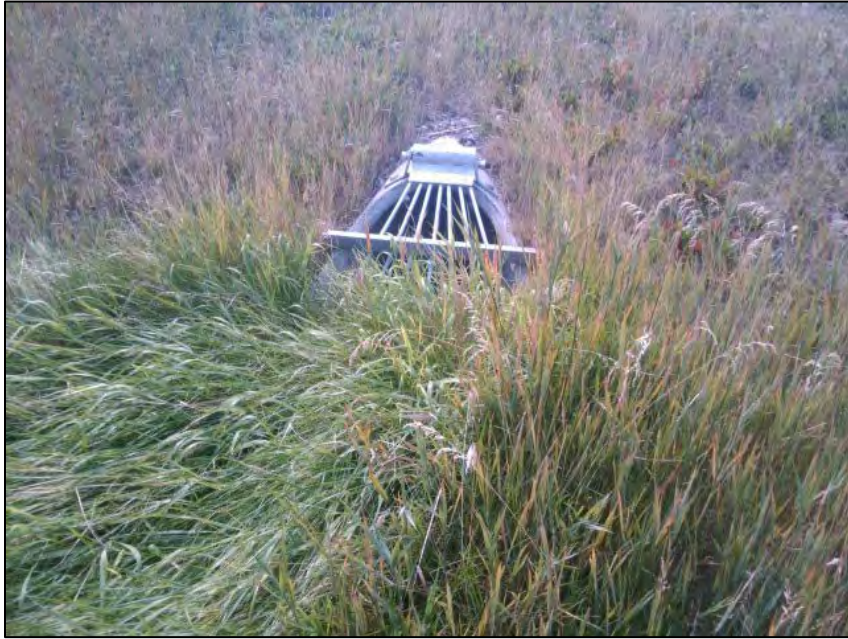
Image 3  
Inlet apron (southwest view). Overgrown vegetation.

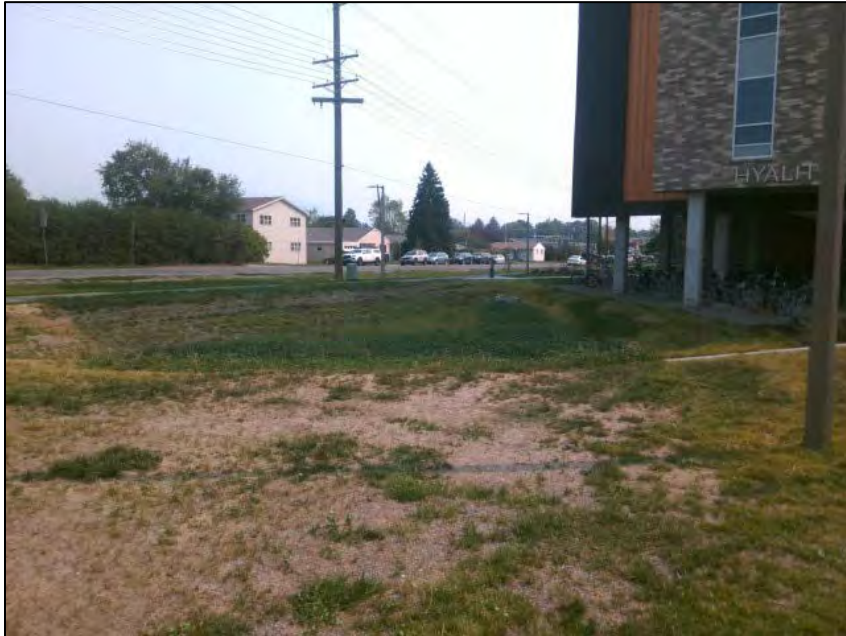
Section 5: Quantitative Analysis				
Vegetation	Cover type	% Within facility	Notes	
	Bare ground	10	Some side slopes not vegetated	
	Aquatics	0		
	Grasses/Herbaceous	90	Red clover overgrowing in bottom	
	Trees >3" DBH	0		
	Shrubs	0		
	Total	100		
Elevation Analysis	Location	Reading (ft)	Elevation (ft)	Notes
	SRV#CP Control Point/ Surface Outlet Top CMP	6.69	100.00	Control
	SRV#1 NW Inlet	8.02	98.67	
	SRV#2 Bottom Outlet	8.1	98.59	
	SRV#3 Center	8.11	98.58	
	SRV#4 Northwest of Center	8.05	98.64	
	SRV#5 East of Center	8.29	98.40	
	SRV#6 South of Center	8.18	98.51	
	SRV#7 Southern Inlet	7.73	98.96	
	SRV#8 Wier Control	8.48	98.21	
	SRV#9 PVC Outlet Invert	9.91	96.78	
	Summary	North pond slope approximately 5.2 : 1

Image 1  
Detention pond overview looking (northeast view). Note bare ground on top break.

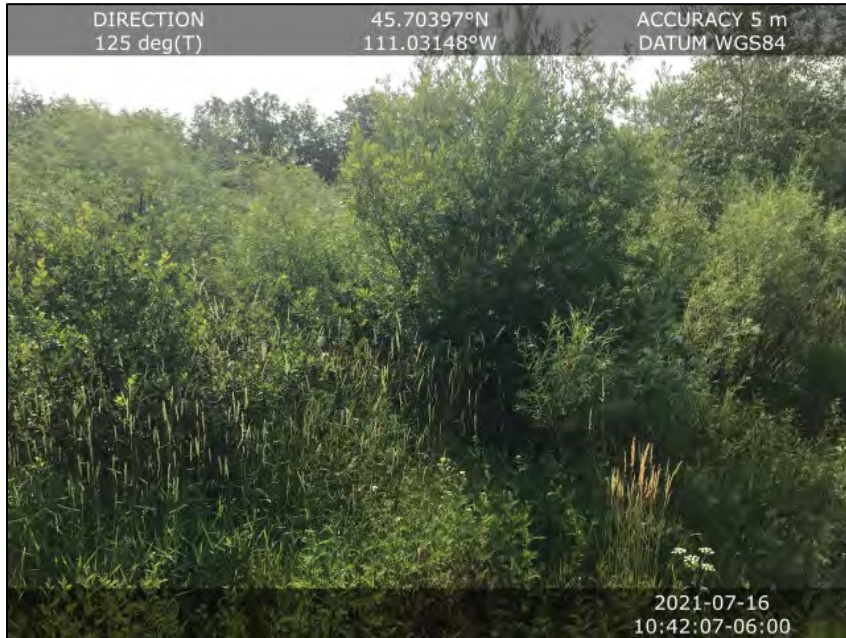
1.2	Debris	Trash, sediment, and waste within and around the facility?	<input type="checkbox"/> Yes <input checked="" type="checkbox"/> No	
	1.3	Vegetation	Overgrown or dead cattails, woody shrubs, weeds, grass, and trees?	<input checked="" type="checkbox"/> Yes <input type="checkbox"/> No	Thick willows and brush in the basin <i>Remove woody vegetation from the basin to restore capacity and infiltration functions</i>

Image 1  
Severely overgrown detention basin

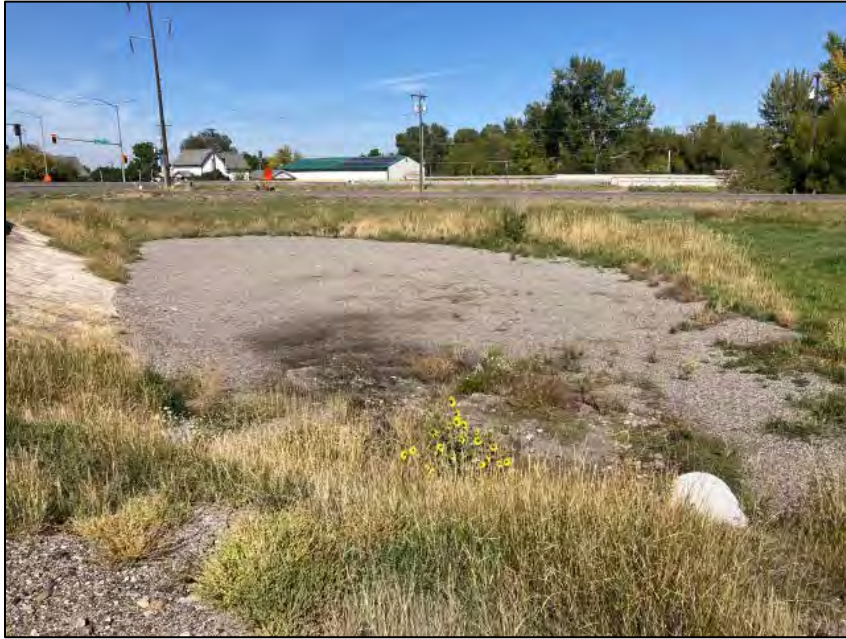
Image 1  
Facility overview. Main pond inlet at foreground (white PVC). Note gravel installed on bottom of impoundment (northwest view).

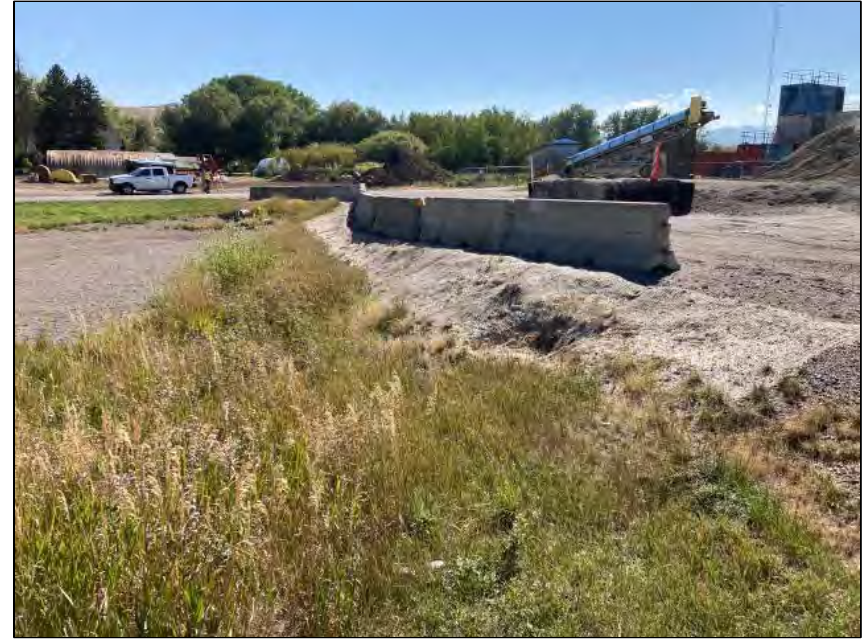
Image 2  
Primary detention basin with traction control aggregate facility on right; note concrete barriers and stabilization blanket installed on the break in slope and pond edge, respectively.

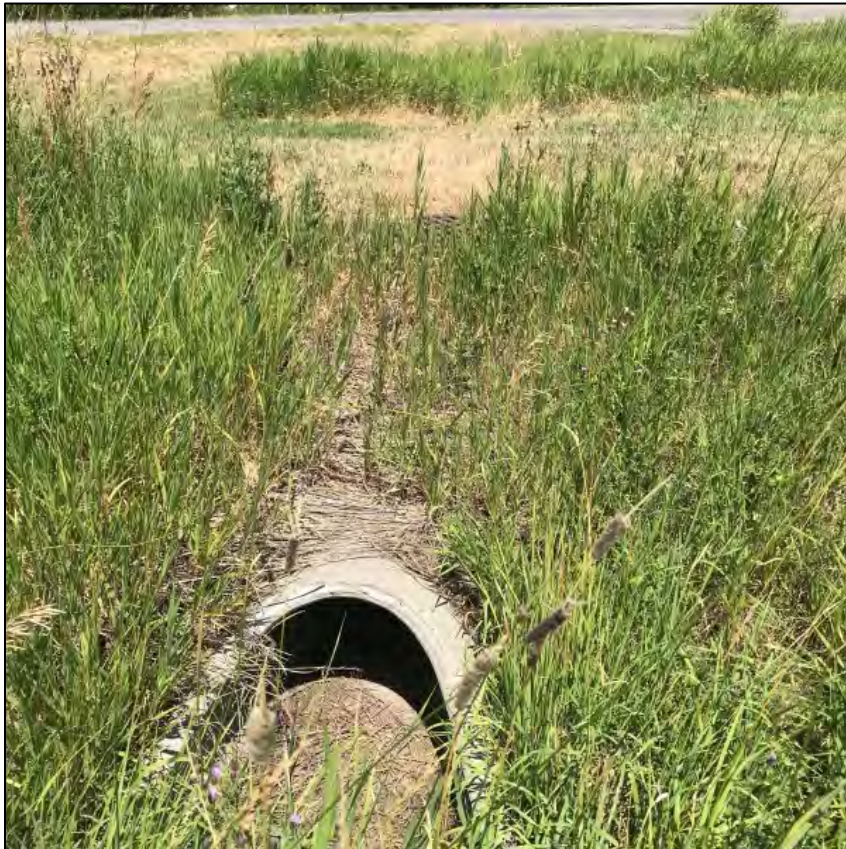
Image 5  
Main basin outlet and outlet structure manhole, the control point, visible above center (east view).

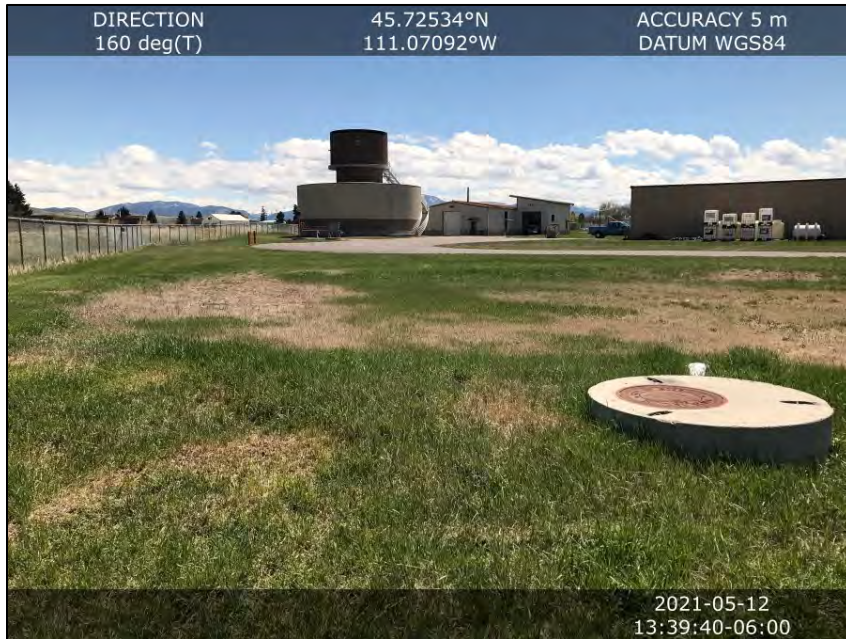
Image 1  
Outlet structure and east half of the facility. (south view)

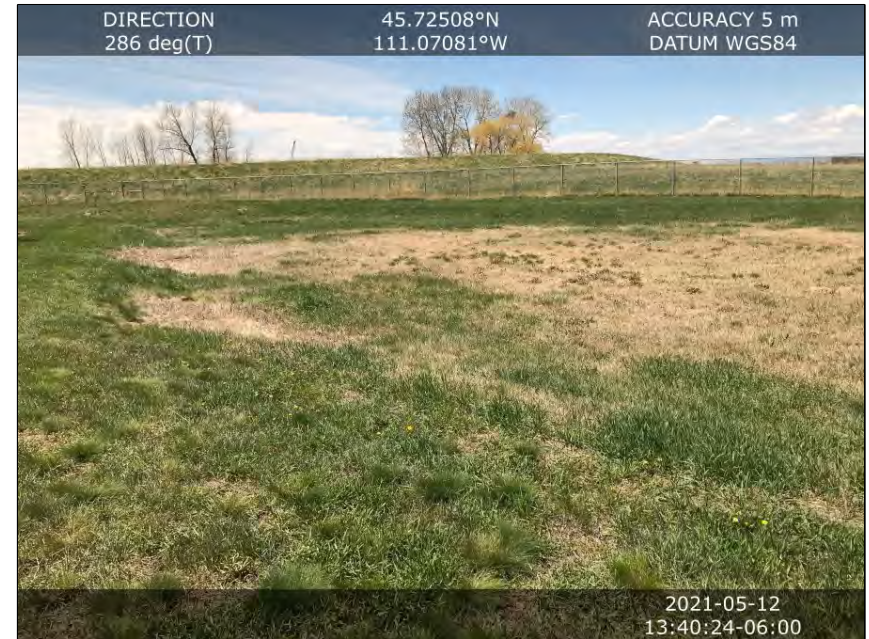
Image 2  
West half of the facility. There is a small swale entering from the background at the left of the photo. (west view)

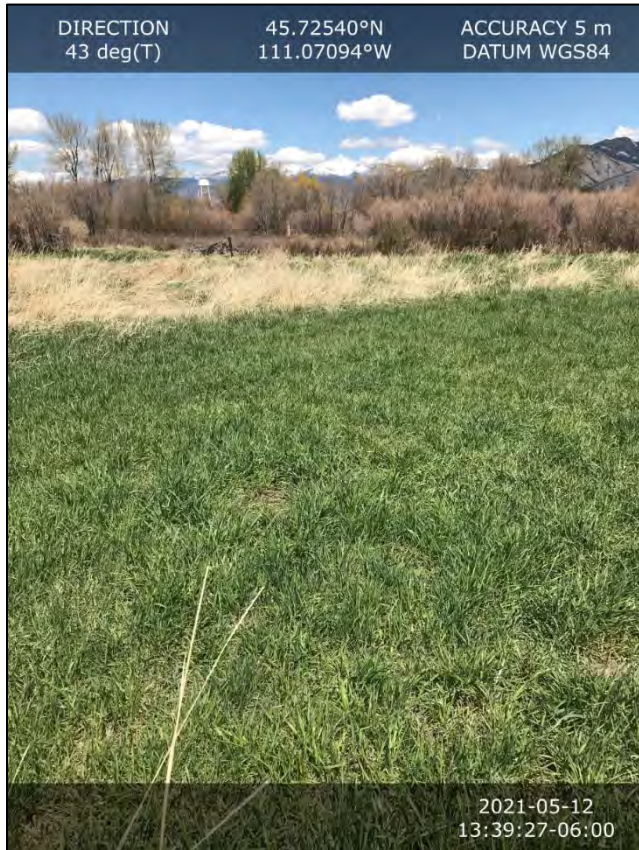
Image 3  
Path of potential discharge toward the East Gallatin River. No signs of flow. (north view)

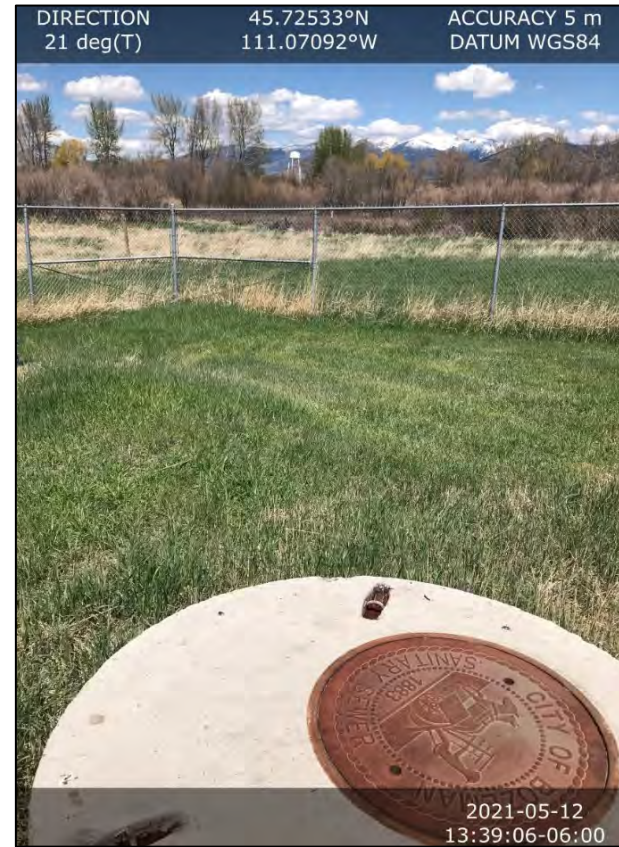
Image 4  
Outlet structure. Outfall is inside the fenced area. (north view)

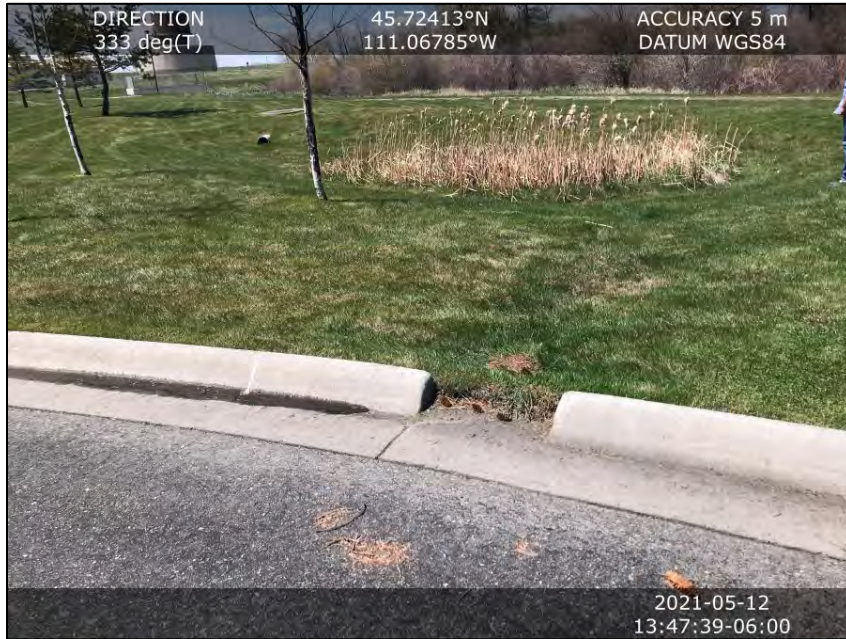
Image 1  
Facility overview. Curb cut at foreground has been cleaned out since last year and curblines have been swept. (north view)

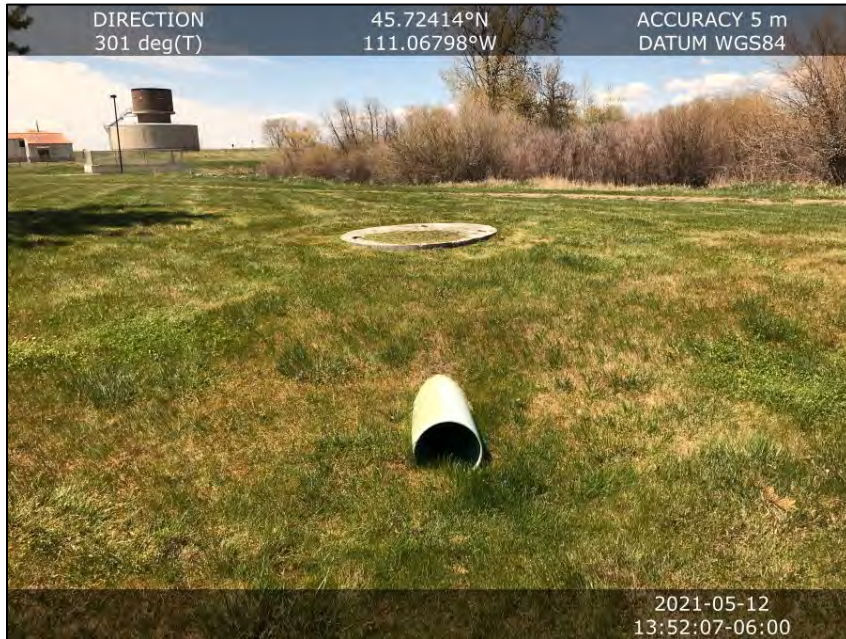
Image 3  
West half of facility, outlet and outlet structure. (northwest view)

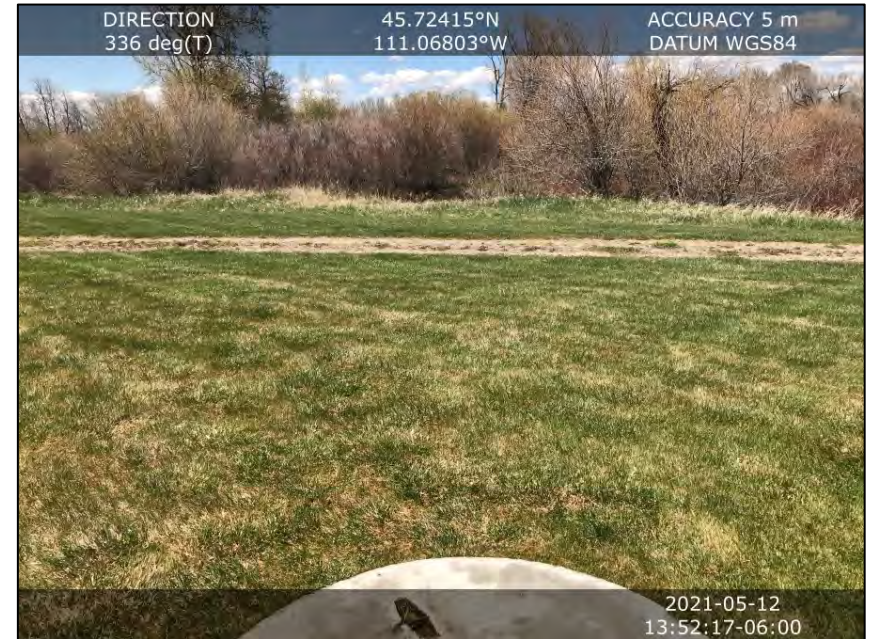
Image 4  
Path from outlet structure to outfall. (northwest view)

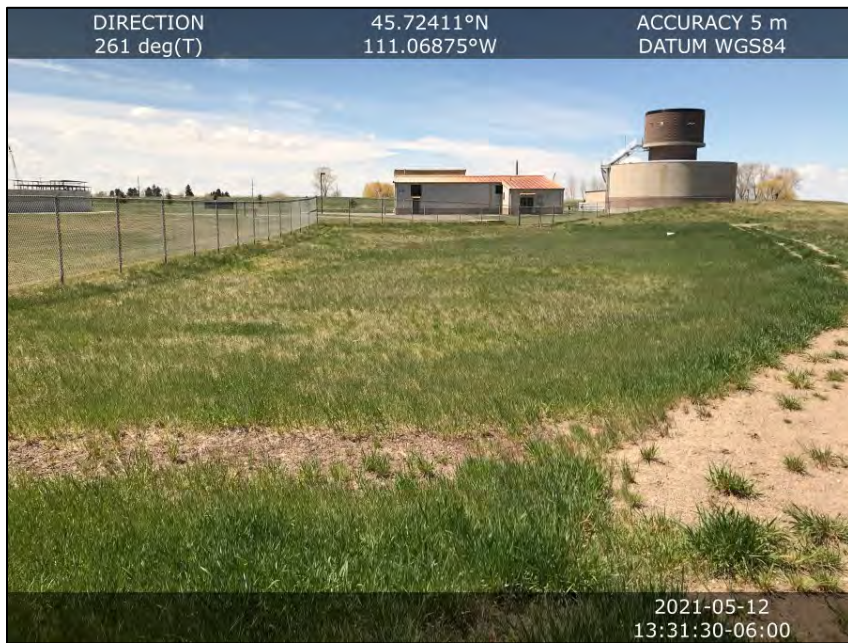
Image 1  
Facility overview, evidence of mowing since last inspection. (west view)

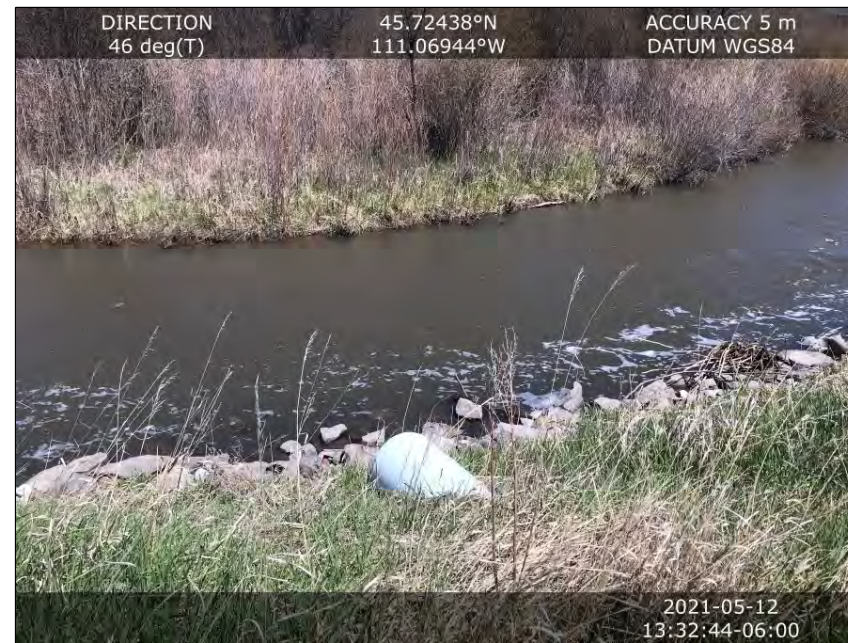
Image 2  
Outfall. (north view)

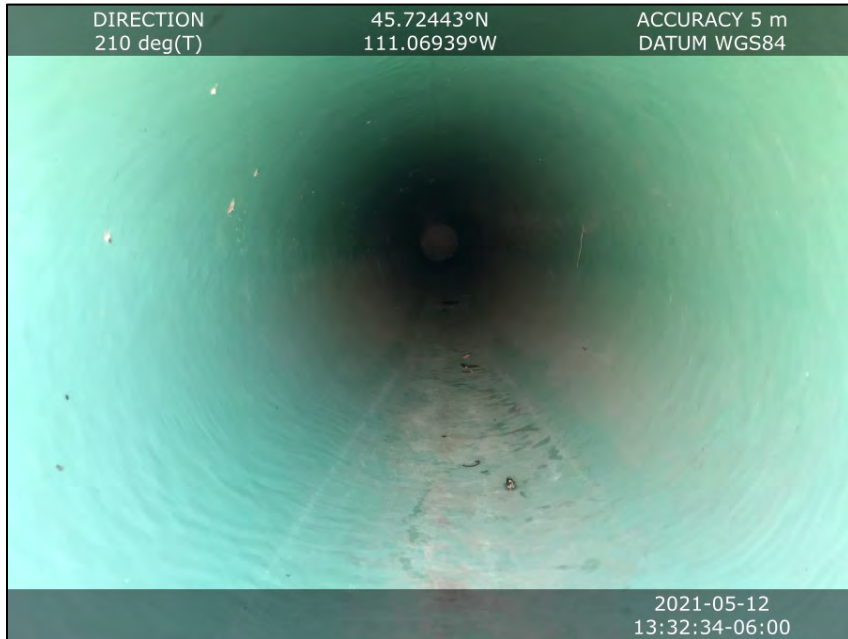
Image 3  
PVC outlet from basin to outlet structure. There is no evidence of recent flow. (north view)

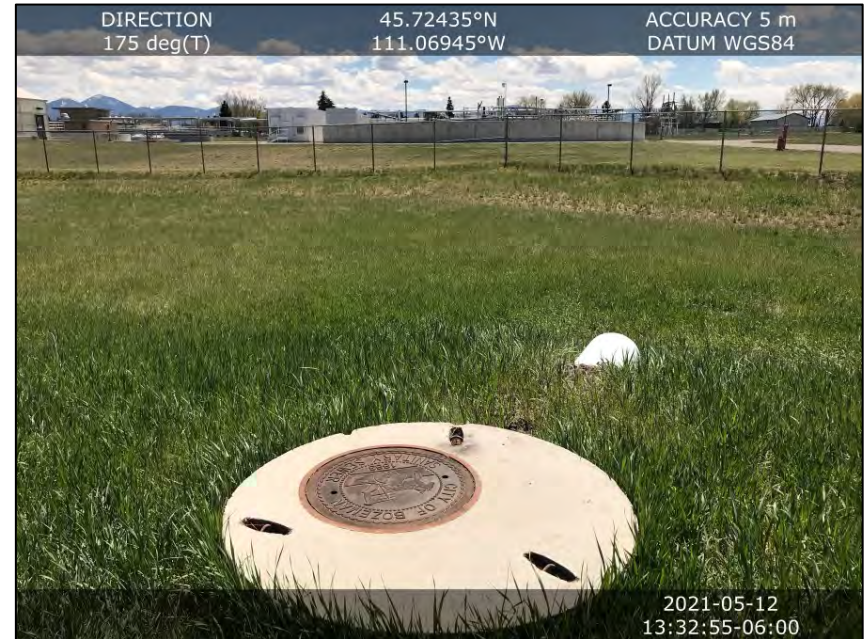
Image 4  
Outlet structure and basin. (south view)
