**MPDES Storm Water Small MS4 Annual Report Form**

Small MS4 Authorization Number: MTR040002

Small MS4 Name: City of Bozeman

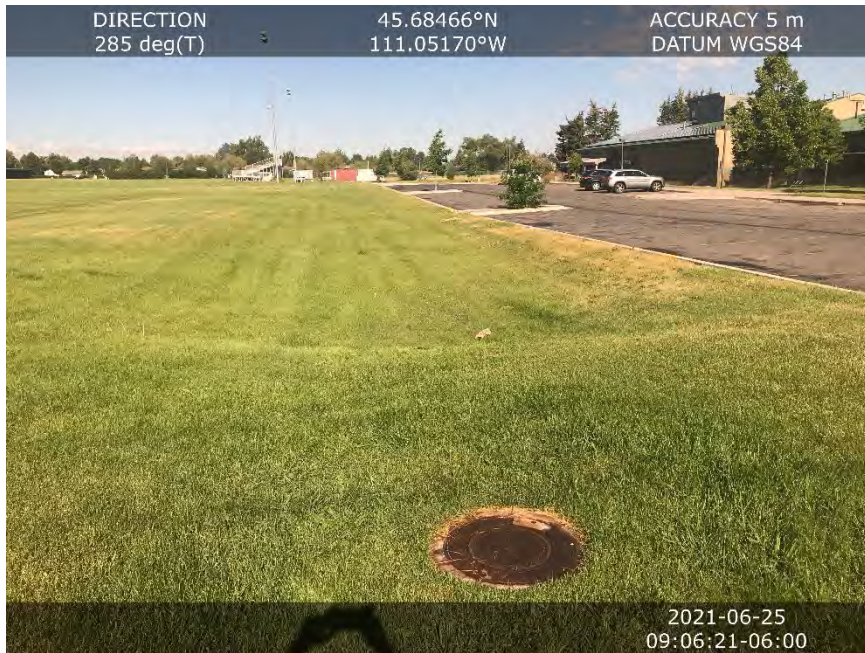
Image 1  
Facility overview. Control point is foreground, outlet structure rim. (west view)

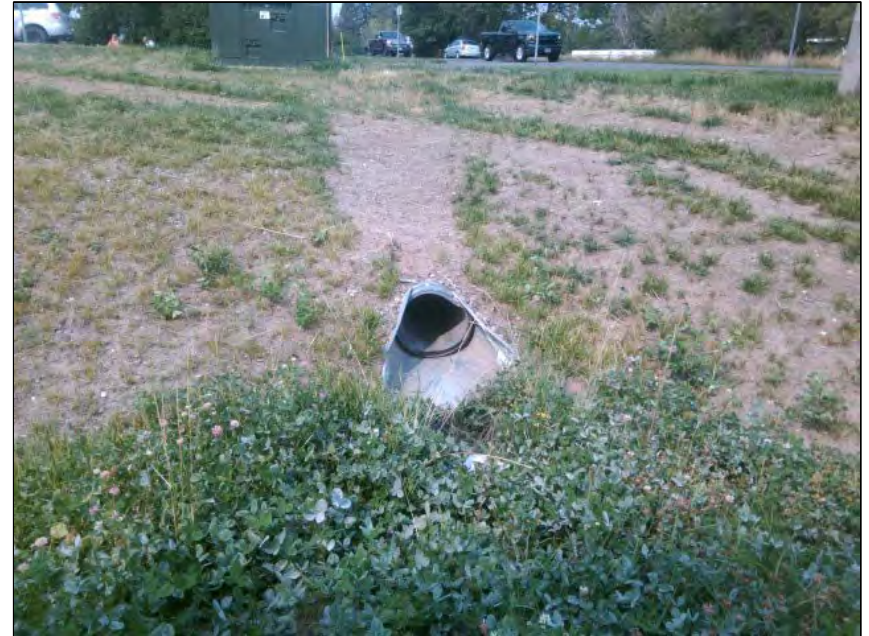
Image 2  
Inlet one; note red clover in foreground.

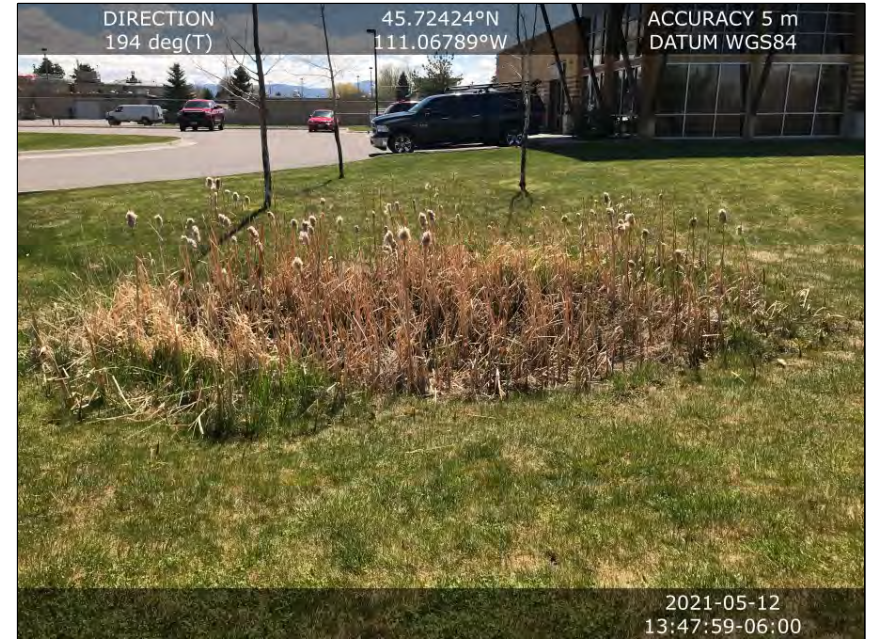
Image 2  
Basin is mowed up to the boundary with cattails. (south view)
